11/14/242/HQ-D / Campaign code	!	Author: AHE	February 20th 2014
Applies to:	Crimping of the wiring harness		
Model:	1190 ADVENTURE/ R/ WES model year 2014 1290 Super Duke R model year 2014		
Restrictions:	The VINs of affected motorcycles have a link on Dealer.net		
Countries:	All

Incorrectly crimped cables for the power supply

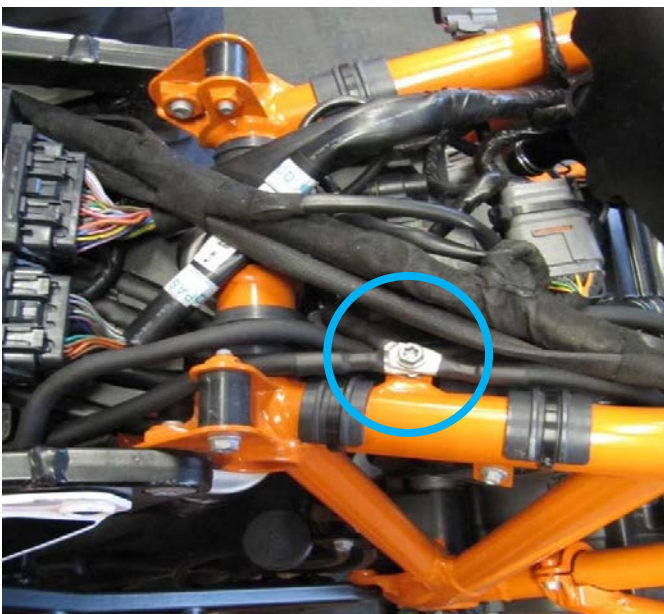
Figure 2:

Ground connection on the frame in the area of the upper shock absorber support.

Important: Place the contact washer back between the frame and cable.

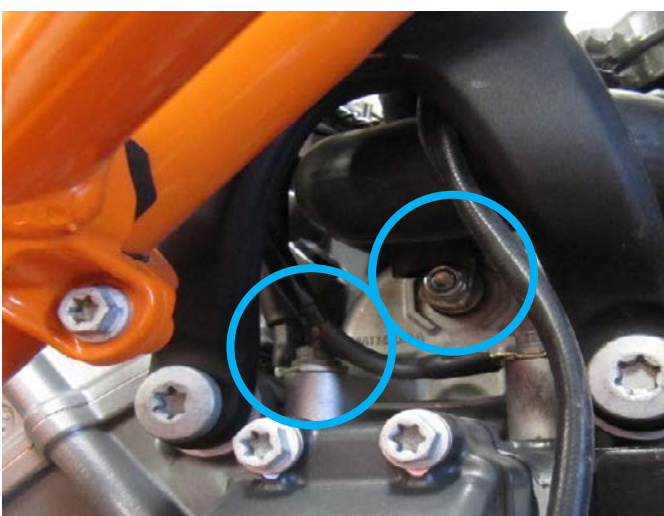
Figure 3:

Both connections on the starter on the right engine side. The ground connection is at the bottom left and the connection of the positive cable is at the top right.

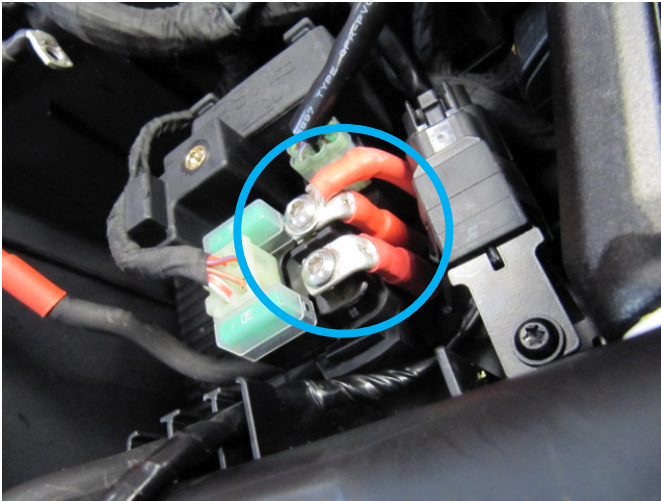
Figure 4:

Connections on the starter relay

Positive side: From the battery to the starter relay
 From the starter relay to the starter connection

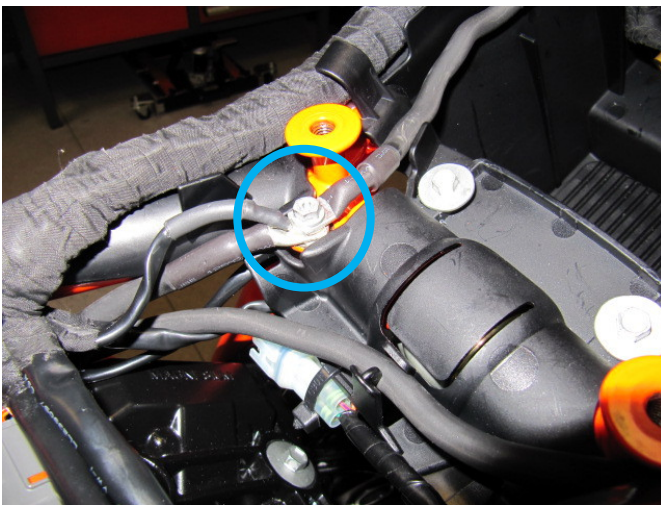
Figure 5:

Ground connection on the frame in the area of the upper shock absorber support

Important: Place the contact washer back between the frame and cable.

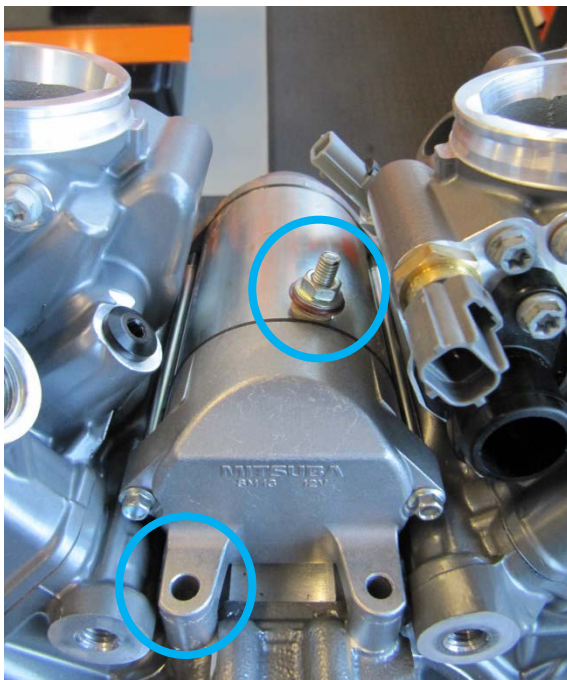
Figure 6:

Both connections on the starter on the right engine side. The ground connection is at the bottom left and the connection of the positive cable is at the top right.
